Johnson County

library facilities master plan
September 2009

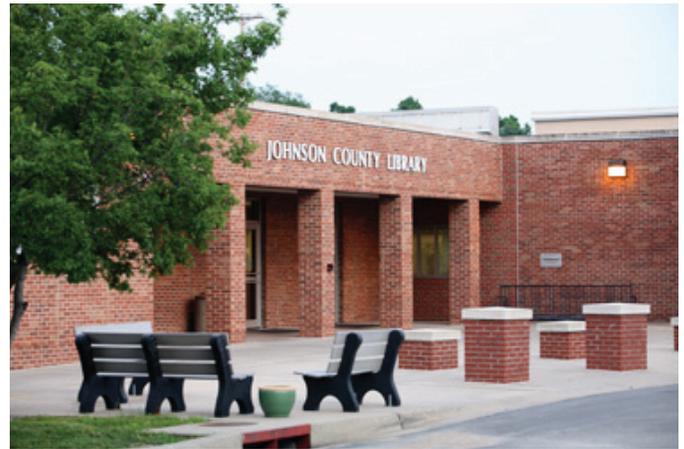
Exterior Walls – Brick Veneer that appeared to be well maintained in most areas. Brick freestanding wall at west side (near trash enclosure) is spalling. Drilled holes in brick on east elevation are open for water and insect infestation. Also, large holes drilled into wall at mechanical area not sealed around conduit. Some areas of cracking in mortar joints and up brick about 4” from corner visible at northwest

Site	F
Building Envelope	B
Building Interior	C+
Infrastructure	C
Service	A
Total Score	D+

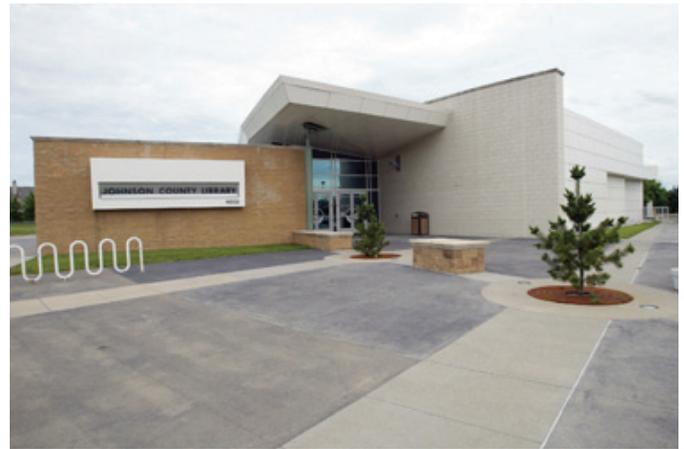
Exterior Walls – Split-face block, burnished block walls, metal panel awning, and glass. The windows have been problematic with blown seals due to air pressure issues in the building. Exterior painted metals throughout exterior are all in the process of losing their paint, some metal is galvanized, some is not therefore rust is showing. Windows are aluminum with insulated glass. Window sills at clerestory do not have counter flashing, creating a possible leak area. Sealant in stone parapet cap needs resealing. Vertical cracking in burnished block at backside of parapet is appar-

Site	A
Building Envelope	B-
Building Interior	A
Infrastructure	A
Service	A
Total Score	A

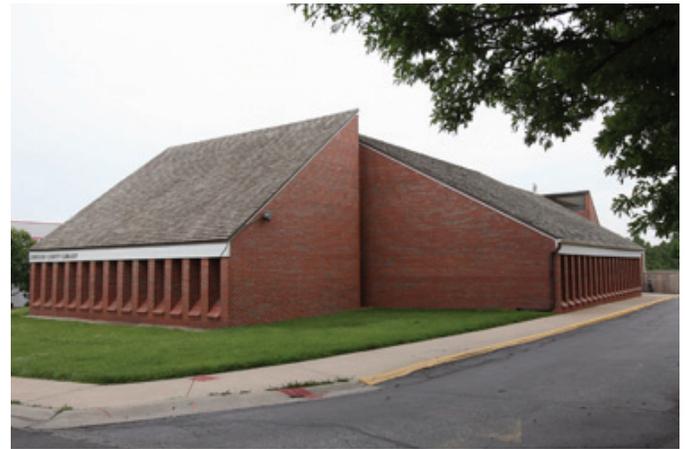
Code - Not Sprinklered. The existing building does not comply with current building code requirements. If any additions are made to this facility, it will require bringing the entire facility up to current codes. There are 3 exits noted in the building, 2 on the west and 1 on the east. The doors on the east side are egress only, however the crumbling stair does not provide a proper egress path from the building. The stairway has a chain across it at the bottom. The 3 exits on the main floor are too close together. Lack of exits leave the mezzanine unusable for program spaces. There are 2 exits out of the basement mechanical and storage space. At the time of the review, the exit out of the mechanical room into an exterior exit way was filled with 8 inches of water. Handrail on stair meets original code, but not current code.

Site	F
Building Envelope	C
Building Interior	C
Infrastructure	F
Service	A
Total Score	F

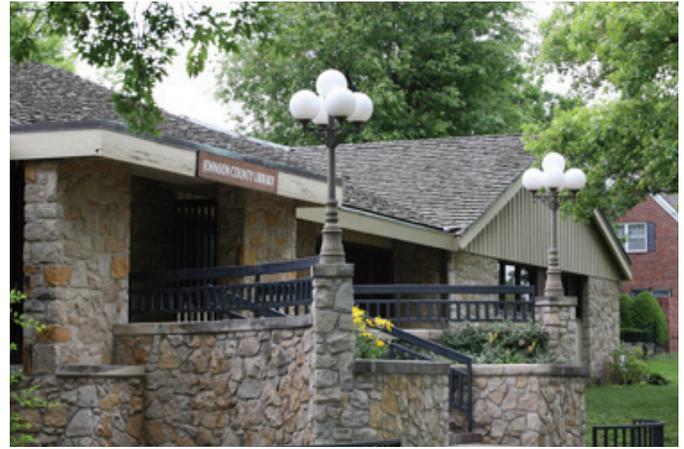
Code – Fire Alarm system has been installed since 2006 report. Non-Sprinklered. Stair from staff space to basement is being used for storage which is impeding egress width. Verify common path of travel rule for egress from north end of public spaces. Exiting the basement is awkward. There are two exits from the basement that exit into exterior sunken gardens which do not have a way out of them. There are two stairways out of the basement, however one goes through staff space which is constrained by items being stored in it. It appears that this would not meet current building codes, however it is not known if there is an existing variance with the City.
