Johnson County

library facilities master plan
September 2009

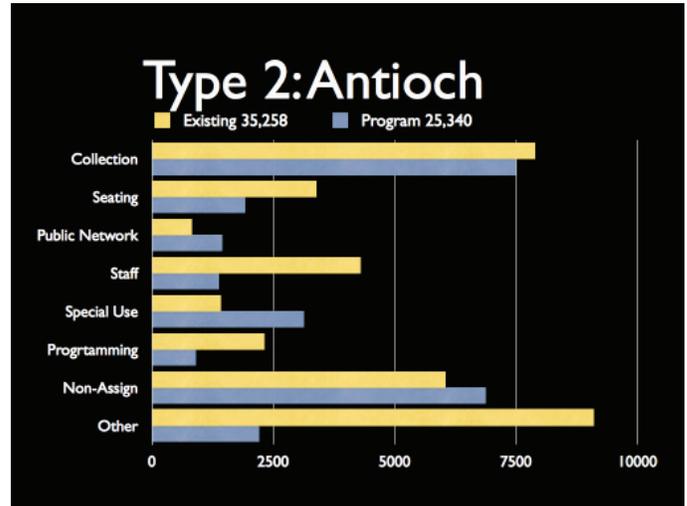
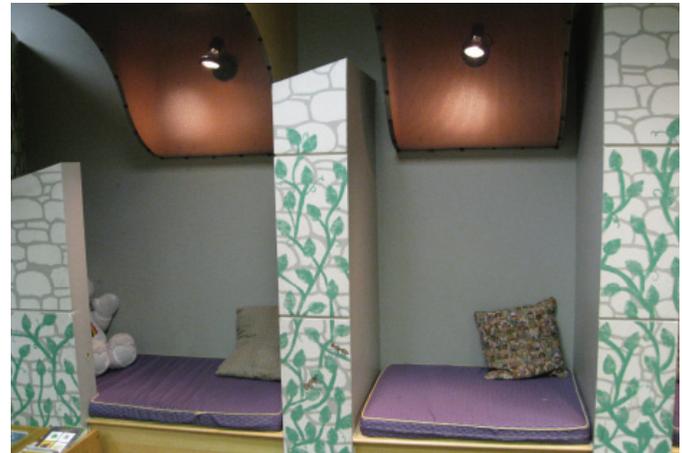
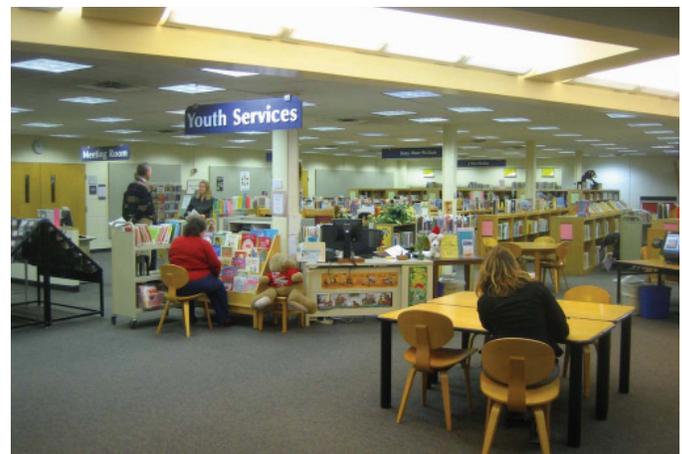
IT – This branch has 3T band width. It is one of the largest in the system. It is stressed which makes the staff functions suffer. There is a re-cabling project underway in the building, but not for the entire building. The IT area conditions cause this system to be at a medium risk of failure per JCL’s outside consultant.

Furnishings – Classic library furnishings in good condition. Mostly wood tables and chairs in main library areas. Lounge furniture present in large reading room. Staff furniture appears to be dated and mixed. Staff breakroom lounge furniture is worn.

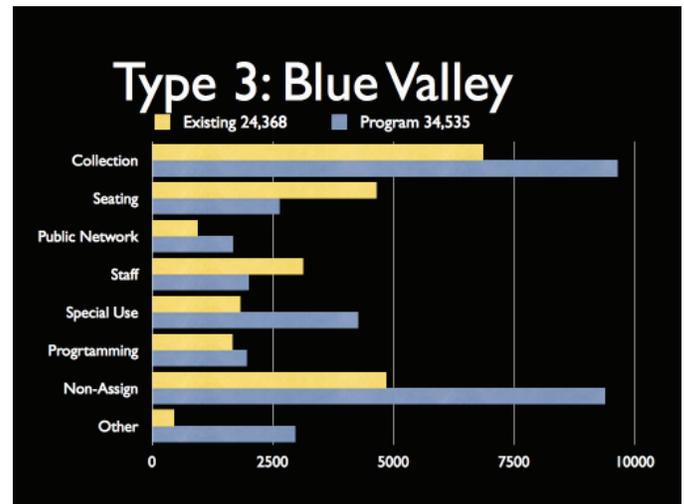
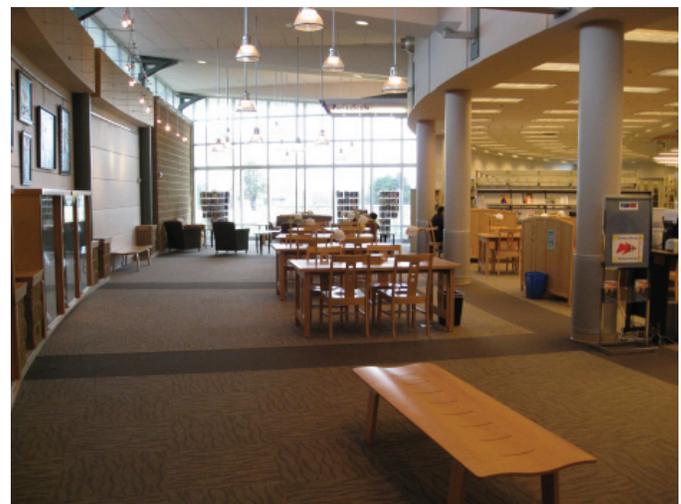
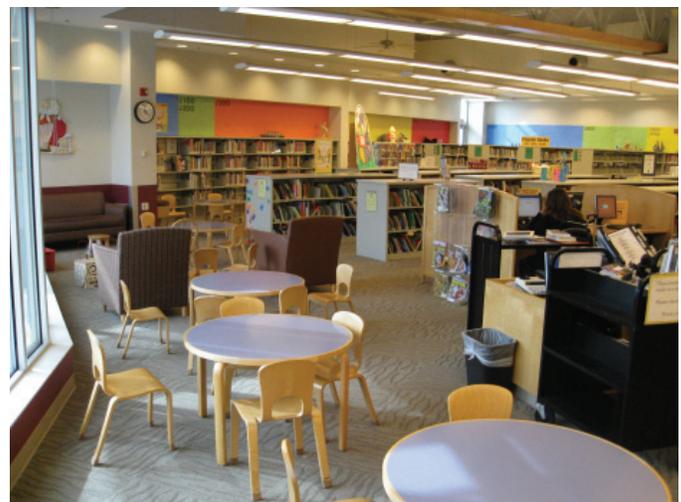
IT- This branch has 2T1 band width. Fiber will be coming into the area in 2009. This building is easy to run cables in. The IT area conditions cause this system to be at a low risk of failure per JCL's outside consultant.

Furnishings – Wide variety of individual and group stations are in good condition. Furniture is natural finished maple with plastic laminate work surfaces. A variety of chair options are also available, i.e., wood chairs, upholstered task chairs, tablet arm lounge chairs, and large lounge chairs. Furniture in staff lounge appears worn.

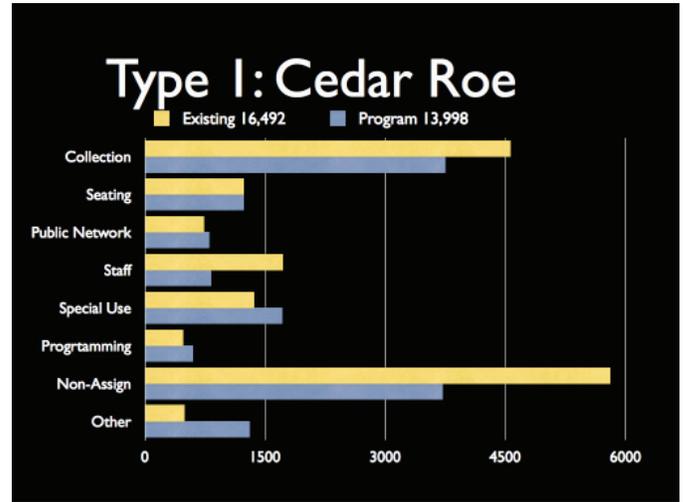
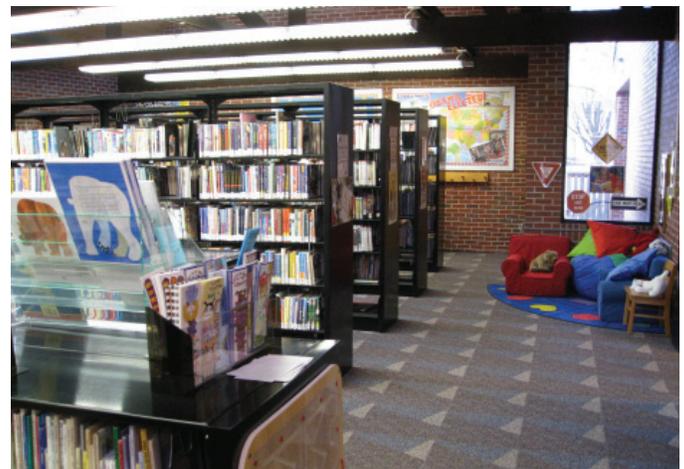
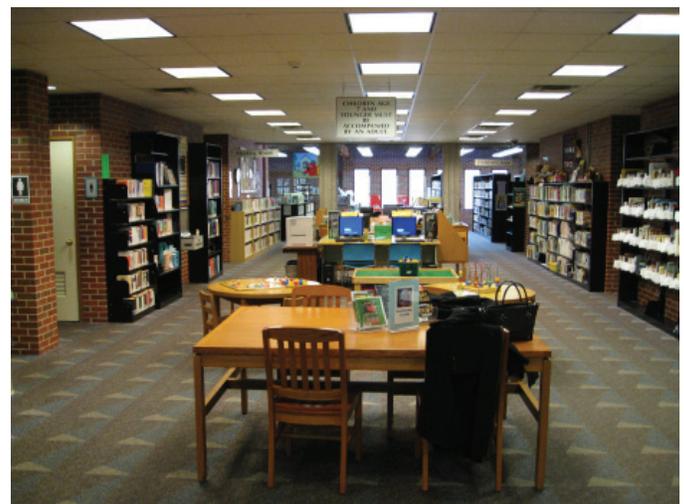
IT Infrastructure – IT controls are in the boiler room in the path around the mechanical equipment. The space is neither adequate nor secured from accidental bumping.

Furnishings – Mostly wood tables and chairs in good condition. Computer stations have desks with upholstered task chairs. The task chairs appear to be a variety of styles. Upholstered lounge chairs are classic library style in good condition. Some old reference desks remain in portions of library. Soft seating in children’s area is wearing.

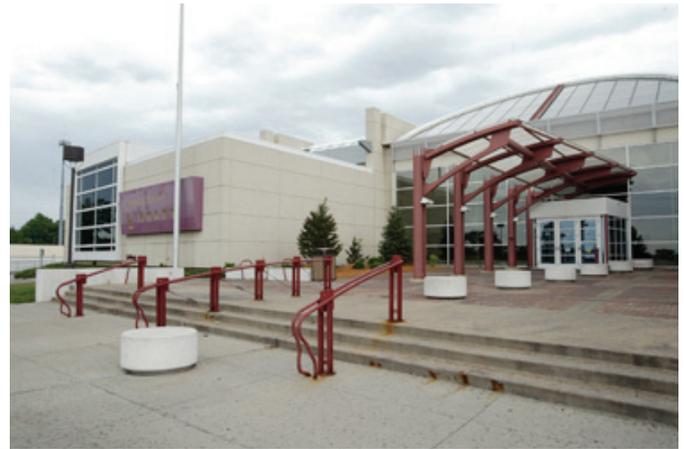
Ceilings – Acoustical ceiling tile in combination of ceiling panel sizes. Ceiling tiles are dirty.

Lighting - 1x4 fluorescent troffers with concealed lighting around the perimeter of rooms provide most of the general lighting in the collection/reader station areas. Lighting appears to be adequate in collection areas. Main circulation axis of building is lit by indirect fixtures that appear to be improperly aligned for best use of available light; therefore,

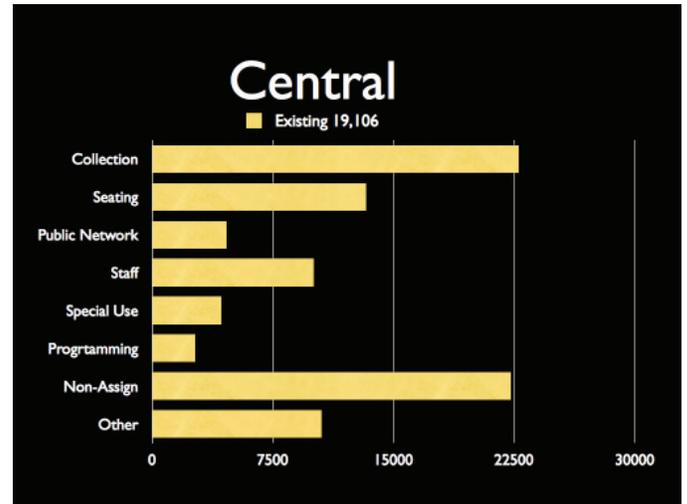
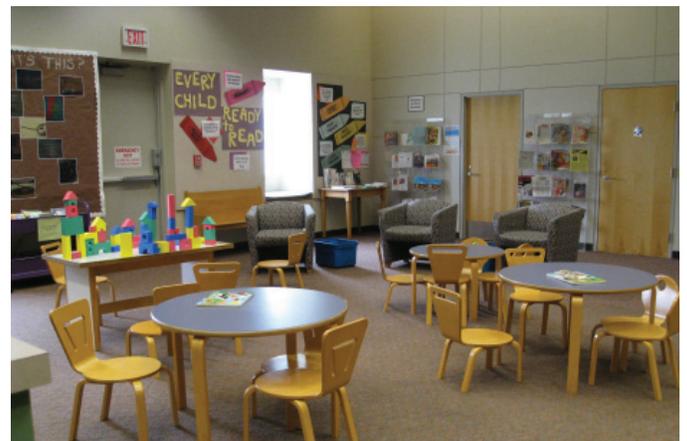
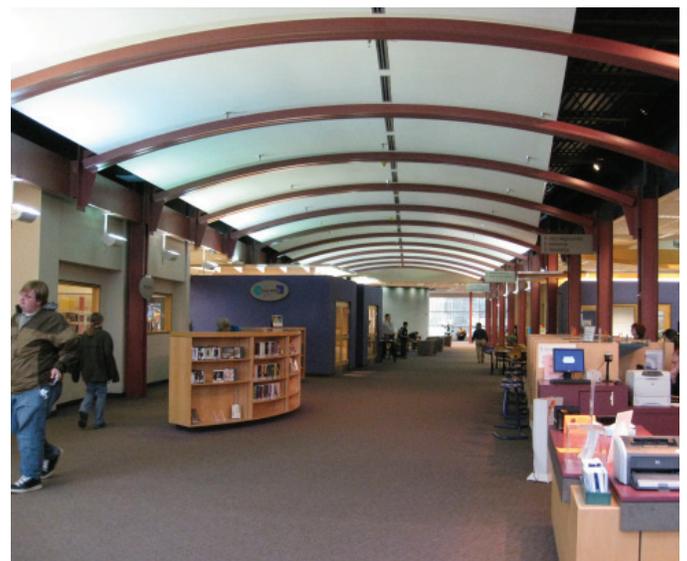
The phone system in CRL is no longer supported. Data jacks locations create cable management issues. Consider furniture options that streamline cable management process.

Furnishings – Public furniture is a collection of wood (maple), plastic laminate, metal shelving, and upholstered lounge furniture. The color scheme is dated; however, many of the non-upholstered pieces are in good condition. Upholstered pieces are showing signs of wear. Lounge furniture in staff breakroom is worn.

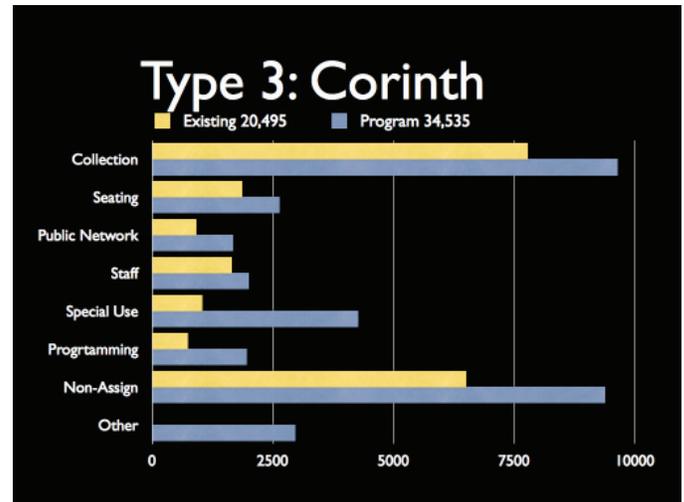
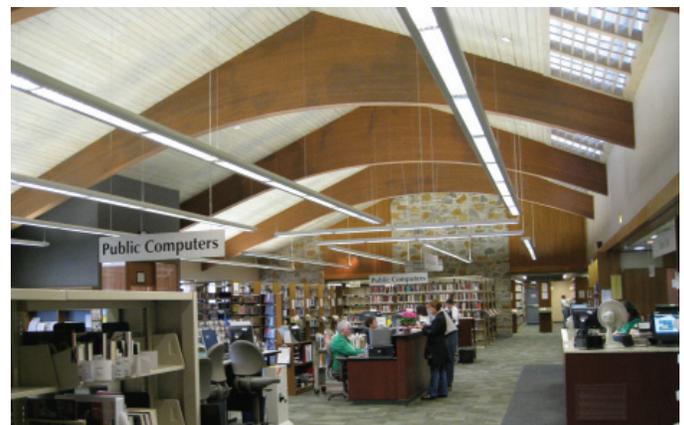
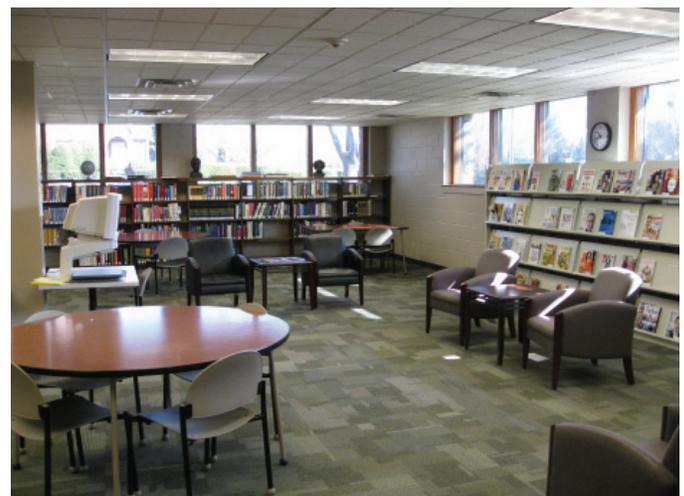
IT- The telecom area at this branch is not adequate and is at high risk of failure.

Furniture – Furniture in staff break room and teen area is worn. Furniture on main library floor consists of plastic seating, upholstered seating, plastic laminate tables metal shelving, and some wood furniture. The furniture is in good condition. Some lounge furniture exists, however they don't appear to be as comfortable as other branch lounge furniture.

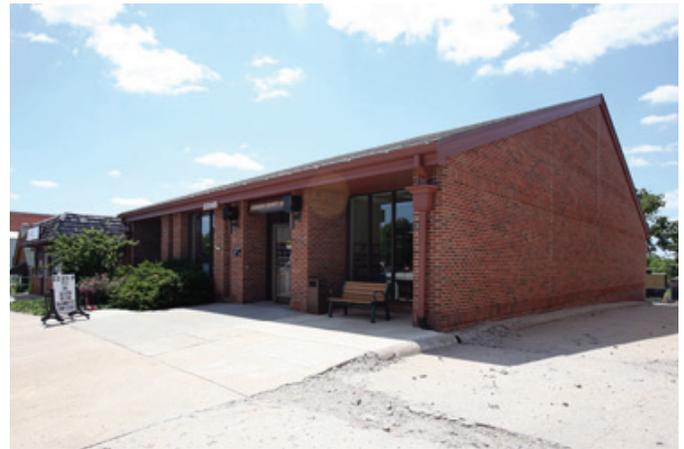
Structure – Masonry. Crack in the CMU wall is noted at south east corner of building at wall of storage space.

Interior – Recently reconfigured and freshened up. New paint on CMU walls. Carpet is in fair condition, however may need replacement in 1-3 years. Break room has VCT flooring with painted block walls. Demountable walls on 2 of break room walls.

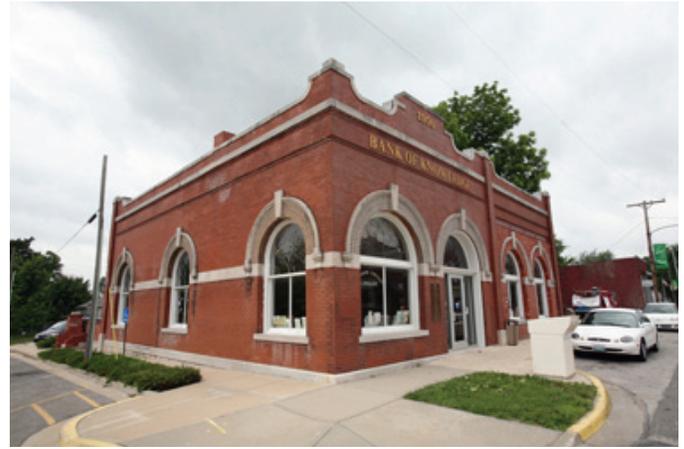
Roof – Built-up. Several leaks present, however it is the City of Edgerton’s responsibility to repair.

Ceilings – Acoustical ceiling tile in good condition except where water leaks are present.

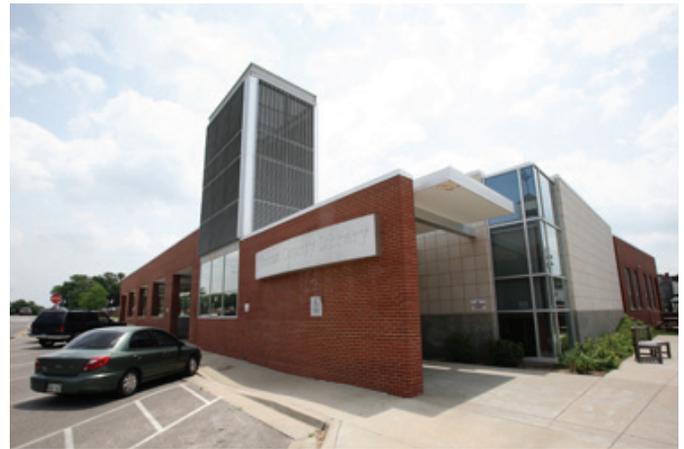
Roof – Modified bitumen roof 8 years old. Seams fail periodically. Re-roof is probably needed in 2-3 yrs. Lightning protection is present on the building.

Exterior Walls – Brick, burnished block, and glass. East exposure is sun fading book spines along the east elevation.

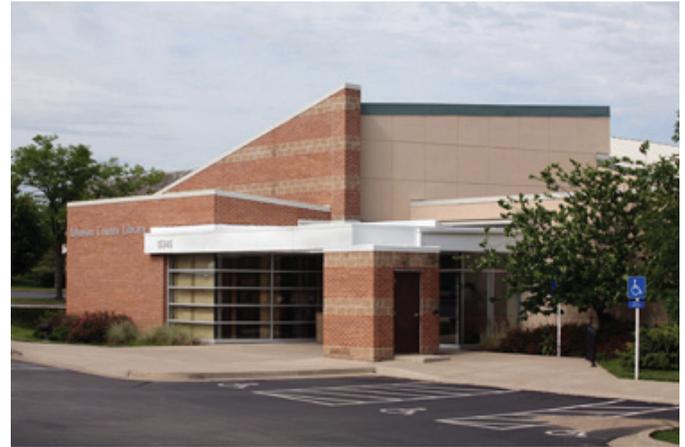
Roof – Modified Bitumen and Standing Seam. There appears to be 1 location where the 2 roof types intersect where a leak is present. There is also a downspout that is creating a leak at the north east corner.

Interior – Carpet tile flooring is in fair condition. Carpet was replaced in 2008. Interior walls are painted gyp board. New paint in high-use areas may be needed with in 1 year.

Ceilings – Acoustical ceiling tile and painted gyp board. Staff areas and Children’s area has flat 9’-0” approx ceiling heights. Ceiling tile in these areas have mild dirt on them. Ceiling in vaulted area is in good condition.

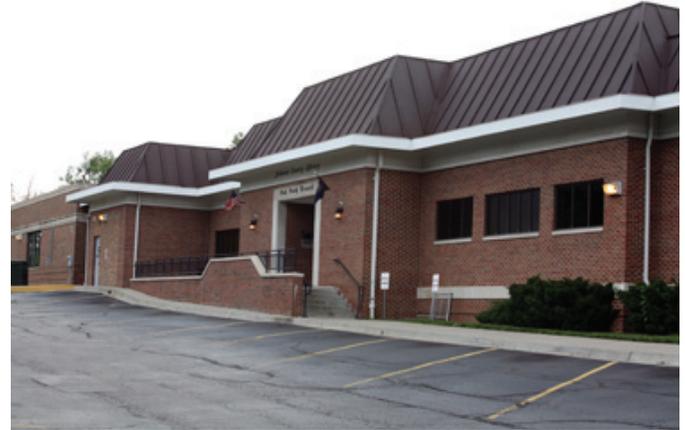
Roof – Mansard standing seam metal roof with stainless steel metal panels as back of parapet.. New EPDM on eastern half of flat room. Modified Bitumen on western addition. EPDM roof appears to need greater crickets for proper drainage.

Exterior Walls – Brick with wood trim and aluminum windows. Brick cracking was noticed. Disconnected downspout noted on east end.

Interior - Carpeted vestibule is worn. Carpet throughout branch is worn, replacement needed within 1 year. Interior walls are painted gyp board. Some newer paint accent walls are in good shape and add warmth to the facility.

Lighting - 2x4 fluorescent lay-in fixtures with lenses provide general lighting. Light levels appear low in some areas of facility.

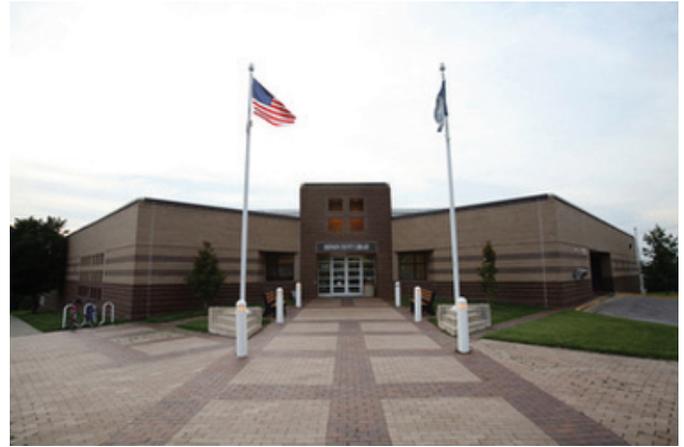
Structure – Steel. Column bases in basement are rusting due to water infiltration at base of windows.

Exterior Walls – Brick and glass. The Brick appears to be in good condition. The glazing is dirty and the window system has leaks. The base of the window system has begun to corrode/rust.

Interior – The interior is mostly carpeted floors and drywall walls. The carpet is beginning to show wear signs. Re-painting interior could be expected in 1-3 years.
